Number of Rope Failures amongst German and Austrian Mountaineers and Climbers since 1968

by Pit Schubert

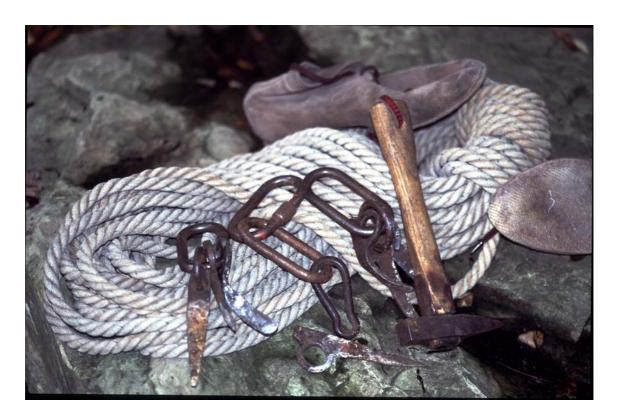
Figure 1: A hemp rope used in the fifties, photo by P. Schubert

Many of those hemp ropes were broken. I lost two friends at that time. If hemp ropes were wet and later on dried, they dried only at the surface. Because of the capillary effect, the dampness stayed for a long time in the rope, and because hemp is a natural product, the hemp rotted. At that time it was possible to tear a 15 mm rope by hand force. Two of my friends tested their hemp rope at the end of the climbing season in such a way. They fixed the rope at a doorhandle. Together they pulled with their body weight, the doorhandle withstood the force, but not the rope. - At that time the rope was intended while climbing only to help the second climber, if he had not enough power. For the first climber it was not allowed to fall, because of the possibility of rope failure. - If nowadays sport climbers used hemp ropes we would have hundreds of thousands of injured or killed climbers each year.

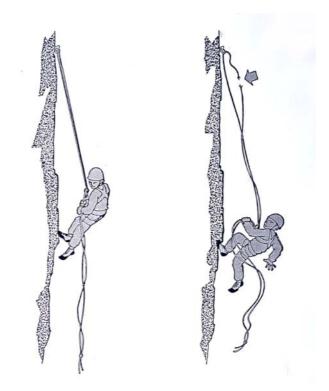
Figure 2: Rope failure during abseiling (influence of acid), figure by G. Sojer

The reason for the remainder of the nine rope failures, which are not recorded in the table, is the influence of polyamide contaminants. In three of the four rope failures the influence of the acid was found out by the chemical institute of the Bavarian Police Headquarters. Fortunately no climber was killed. One of these rope failures happened in the Wilder Kaiser, on the Predigtstuhl during abseiling (Figure 2).

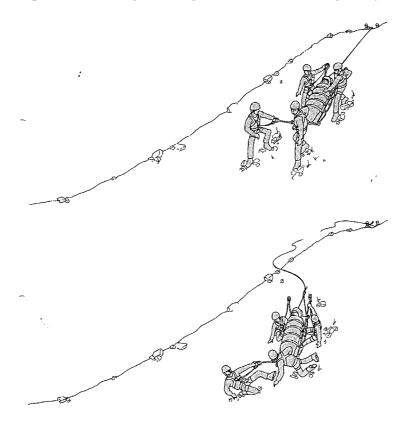
Figure 3: Rope failure during training a mountain rescue team (influence of acid), figure by G. Sojer

The second rope failure happened during a training of mountain rescue teams on a not very steep slope (see Figure 3) and the third rope failure happened during a flying fox (Tyrolean

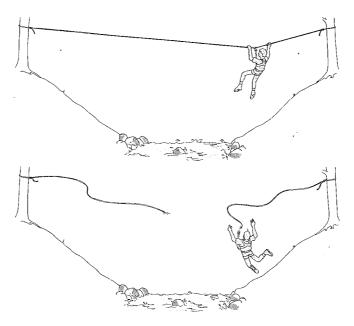
Figure 4: Rope failure during a flying fox activity, also called Tyrolean Traverse (influence of acid), figure by G. Sojer

Traverse) activity (Figure 4). In all three cases the load was so low, that a breakage of the rope is unbelievable, except if already damaged by acid or some other polyamide agressive ontaminant.

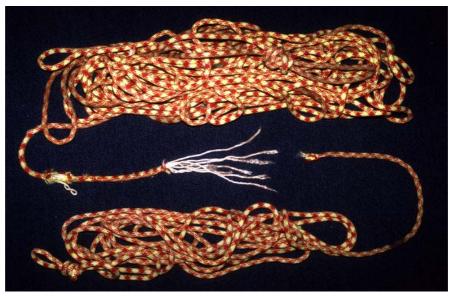
Figure 6: A rope failure by a fall over a sharp rock edge, photo by P. Schubert

There are two characteristics indicative of polyamide rope failure due to acid contamination. One characteristic is the general appearance: Figure 5 shows a rope broken by the influence of acid (both ends look similar), and Figure 6 shows a broken rope, loaded over a sharp rock edge (both ends look quite different).

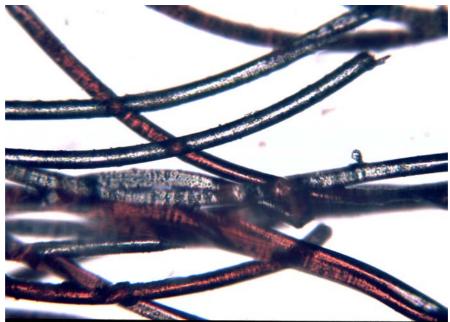
Figure 7: Filaments of the broken rope during abseiling, photo by P. Schubert

The second characteristic is the microscopic appearance of the ends of the polyamide filaments. Figure 7 shows the effect of acid, no heads at the ends of the filaments, because the rope does not absorb energy; I tested ropes which came in contact with acid on the Dodero-test-machine, they break like a shoelace.

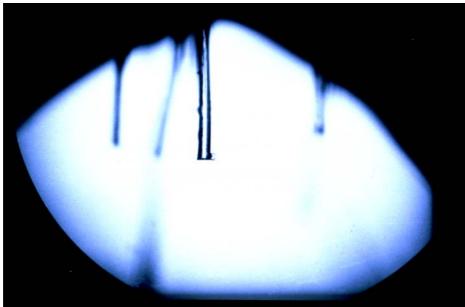
Figure 8: Filaments of a broken rope, when loaded over a sharp rock edge, photo by P. Schubert

Figure 8 shows the effect of a sharp rock edge (when loaded by fall over a sharp rock edge), small heads on the ends of the filaments, because the rope absorbs a part of the energy. To complete this explanation: Figure 9 shows the filaments of a rope which has failed on the Dodero-test-machine, broken at the orifice, large heads due to large energy absorption.

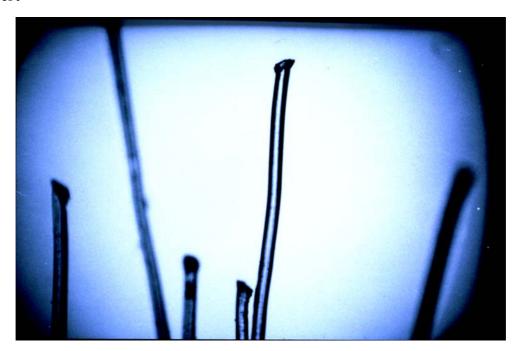
Figure 9: Filaments of a broken rope, when loaded on the Dodero test-machine (normal rope testing in accordance with the standard, EN and UIAA Standard), photo by P. Schubert

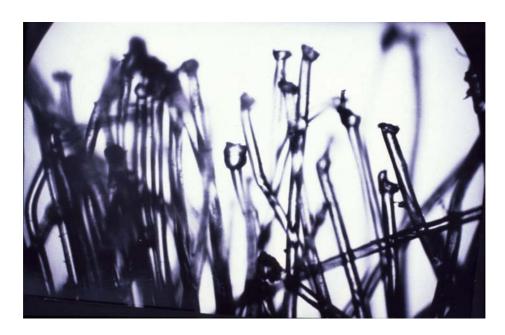
Figure 10: Filaments of a rope failure due to being cut by a knife, photo by P. Schubert

And Figure 10 shows the filaments of a rope failure, due to being cut by a knife. - Every man should be careful, if he wants to get rid of his wife. Cutting can be recognized under the microscope. Last year, when I told this to some German mountain guides, one of them asked: Okay - but what shall we do then? - End of joke.

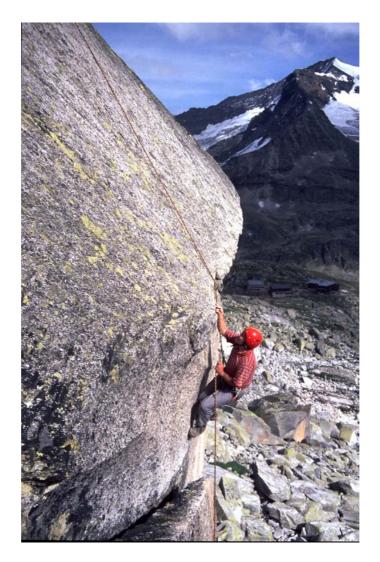
Figure 11: The fourth rope failure by polyamide aggresives contamination happened here, at the rock edge, photo by P. Schubert

The fourth rope failure by polyamide aggresive contamination I was unable to investigate, because when I was informed the rope no longer existed. This rope failure happened near Rudolfshütte (in the Glockner range in Austria). I investigated the circumstances using similar ropes. The rope failure happened during abseiling on a single strand with a single rope of about 11 mm diameter, loaded over a rock edge (Figure 11); the climber was killed. I went with the mountain guide, who was the trainer of the climbers when the accident happened, and at the place of the accident loaded different similar ropes in the same way.

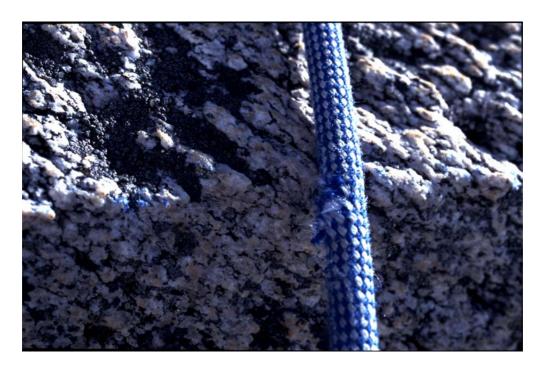
Figure 12: No rope failure, only the sheath was damaged a little bit, photo by P. Schubert

I loaded the ropes with my body weight and made as big pendulums as possible, within the bounds of safety. The result: no rope broke (Figure 12); I did the same with twenty-, thirty-, thirty-six- and thirty-nine- year-old ropes, but no rope broke, only the sheath was damaged a little bit, the sheath of the thirty-nine-year-old rope broke completely (Figure 13). Then I did the same with new and old half ropes, but no rope broke. I continued with an 8 mm accessory cord, but no breakage, only the sheath was broken. - In my opinion the reason for the rope failure in this accident could not be normal rope use, only contact with polyamide aggressive contamination, with acid or something similar.

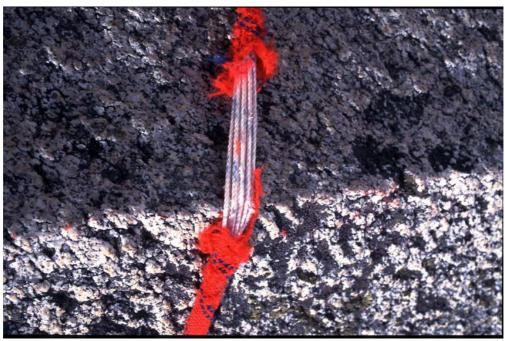
Figure 13: The thirty-nine-year-old rope: No-complete rope failure, only the sheath broke completely, photo by P. Schubert
