THE AFFECTS OF USE ON THE STRENGTH OF CLIMBING KARABINERS

4th Year Meng in Mechanical Engineering

Technical Paper

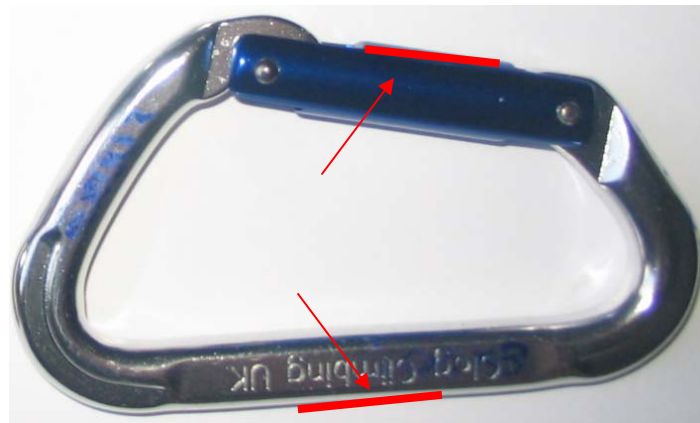
In order to gain an understanding of how the load was disturbed throughout the karabiners when worn and unworn whilst loaded in the closed gate condition under major axis loading strain gauges were placed on two of each type of karabiner. The picture below, figure 3, shows the location of the strain gauges on the karabiners.

Figure 3: A diagrams showing the placement of the strain gauges on the karabiners

The location of the strain gauges were chosen because under major axis loading the greatest loads are experience by the gate and back bar and thus by placing the strain gauges here the full extent of the difference between the two types could be seen [3&4].

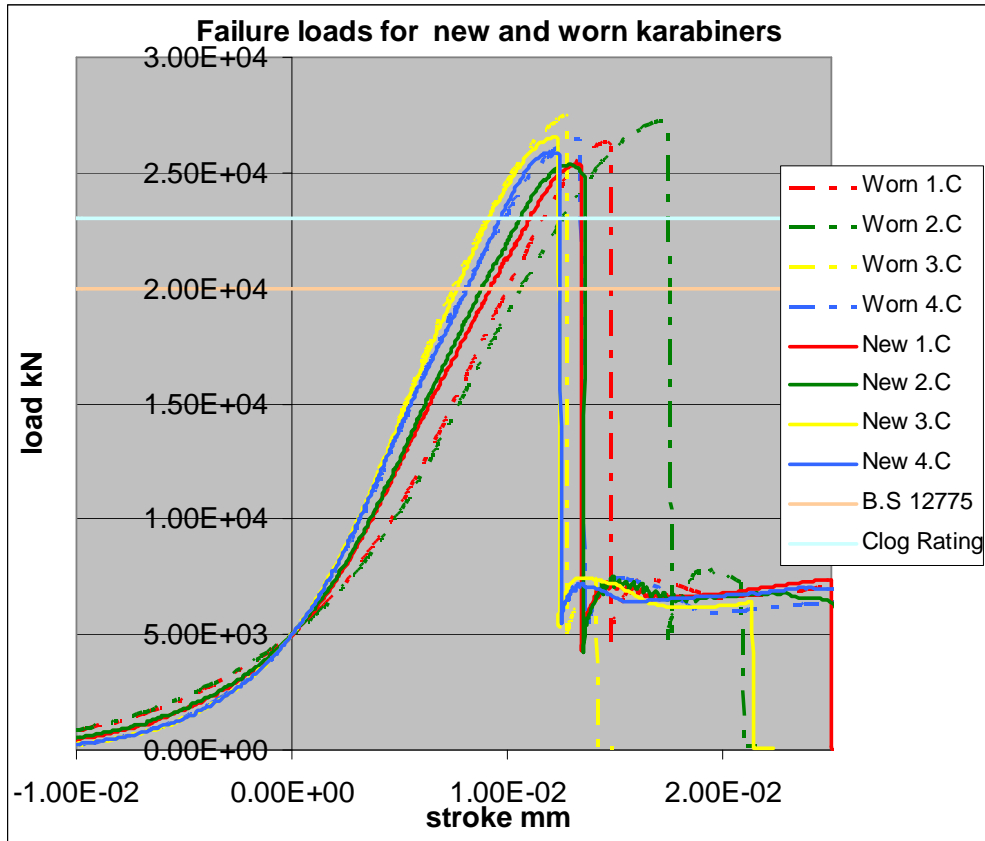
Chart 4: A Graph showing a comparison of the failure loads for the new and worn karabiners under major axis loading

The main result that has come from the major axis testing under closed gate conditions is that both sets of karabiners, new and worn, failed having surpassed both the British Standard requirement of 20kN and their manufacturers rating of 23kN. The average failure load for the new karabiners was 25.7kN with a standard deviation of 1.10. The

average failure load of the worn karabiners was 26.8kN with a standard deviation of 1.05. These results suggest that the variations between similar types of karabiner are very small with the worn karabiners reaching a slightly high peak load than the new karabiners.

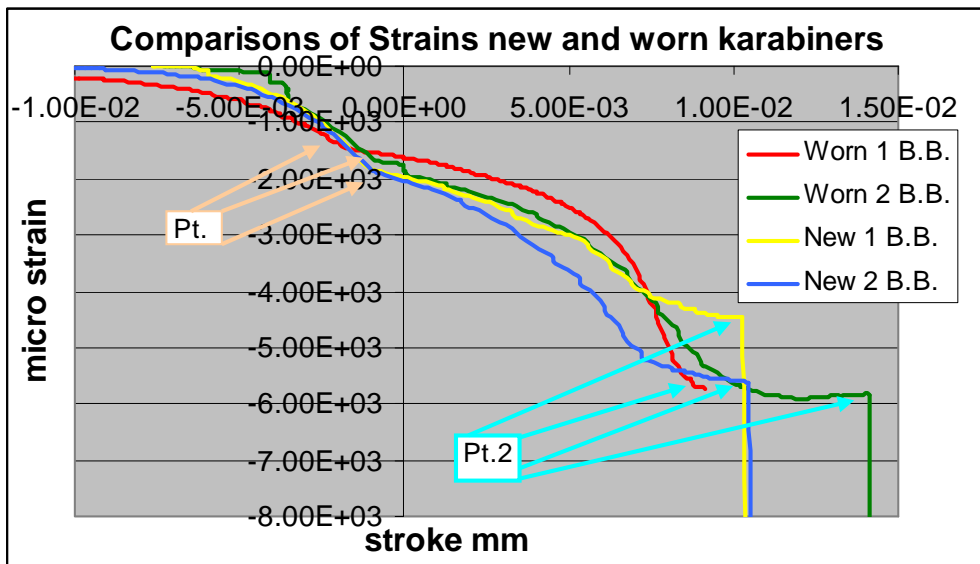
Chart 6: A graph showing the comparisons of the strain through the back bar of the karabiners for new and worn karabiners. Pt.1 shows where the pin first contacts the hinge putting strain onto the gate, Pt.2 shows the karabiner failing and strain being transferred back fully onto the back bar.

It is important to note from charts 5 & 6 is that there is a difference in strains between the two worn karabiners. Unfortunately the test for the worn 1 karabiner was required to be retested using different types of gauges and on a different tensile test machine as the original test did not work correctly. Although the machine was run under the same conditions as the first, with the same stroke speed and method of loading, the fact that a different machine was used meant that not all of the data was available in order to plot the graphs. Compared to the results of the others, worn 1 is a plot of the tensile test machines stroke value versus strain instead of the stroke value recorded by the strain gauges versus strain. This has obviously caused a difference in the graphs appearance however the result was included as there are similarities with the worn 2 data.

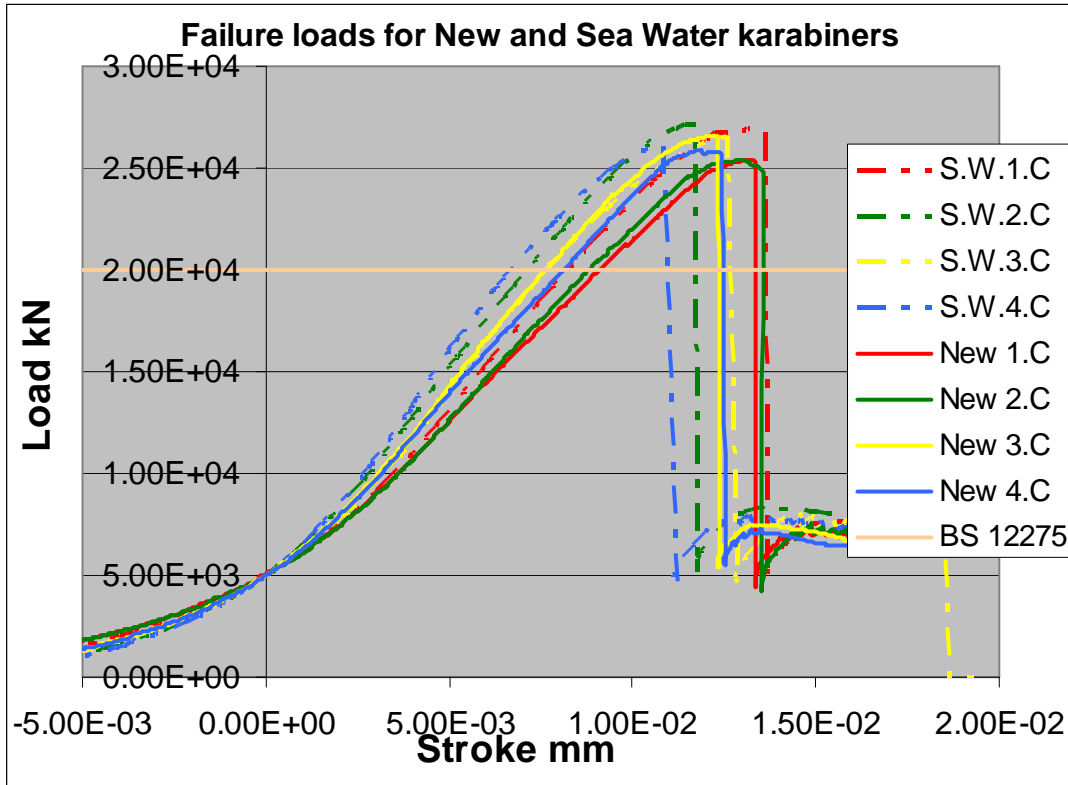
Chart 10: A Comparison of the failure loads of the sea water karabiners to new karabiners

All of the karabiners failed having surpassed the specification set by BS/EN 12275.

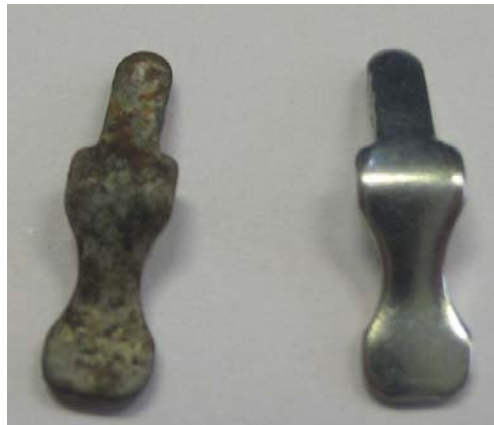
The second visual fault which was evident was signs of corrosion on the main body at the base of the gate where there is a section of material which is used to ensure that the gates spring remains in place. This corrosion can be seen in figure 9 in section 10.1 and can also be seen below in figure 11 where it has been removed from a broken sea water karabiner and is compared to the same part from a new karabiner.

Figure 11: Comparison of spring retaining clips from sea water karabiner (left) and from new karabiner (right)

The final defect which was noted after the karabiner had been exposed to the salt water solution was the stiffness of some of the gates on initial opening. The reason for this stiffness was most likely caused by rusting both to the clip and to the spring itself.
